Volume 63  
Issue 2 *The Innovation Issue*

## Engineering Oops: Florida International University Pedestrian Bridge Collapse

Austin Crawford

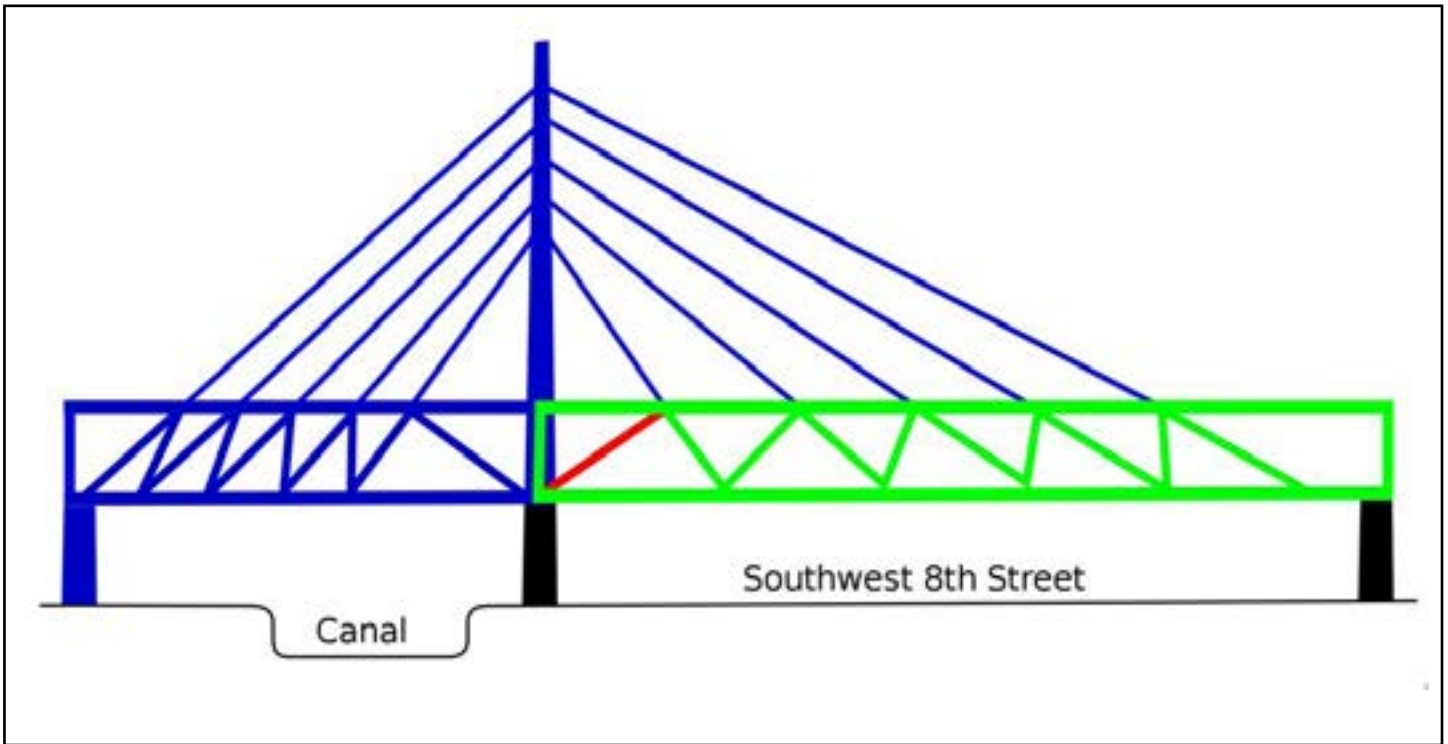
Diagram of the FIU pedestrian bridge with the critical member highlighted in red

Several independent structural engineers performed their own analyses of the bridge design and reached the same conclusion on the design. They determined the bridge’s design to be unsound, particularly at the member connecting the support column on the main span opposite from the main support column in between the two spans to the upper canopy. They deemed this member to be critical since failure in that member would cause the support column to fail, and, subsequently, cause the entire bridge to collapse. Based off the engineers’ calculations, it appears the bridge design firm made the member too thin to support the required load. The likely reason for this error fell to a miscalculation in the original design plans, since the truss contained thicker members elsewhere, but they bore less of a load than the critical member in question.

Even before the collapse, reports came in that cracks formed within the truss structure near the critical member, but the head engineer of FIGG brushed these reports off, claiming that they held no major concern. Repairs would be made to the cracks later. The day of the collapse, workers for MCM Construction, the company contracted with constructing the pedestrian bridge, began tightening internal support rods within the bridge, possibly as a method to prevent the cracking from spreading further. It is highly speculated that this tensioning increased the load within the critical member of the truss past its breaking point, causing the joint at the member and the vertical support column to fail “explosively,” in turn collapsing the entire main span of the bridge onto the highway below.
