Engineering Oops: Florida International University Pedestrian Bridge Collapse

by Austin Crawford, Mechanical Engineering Junior

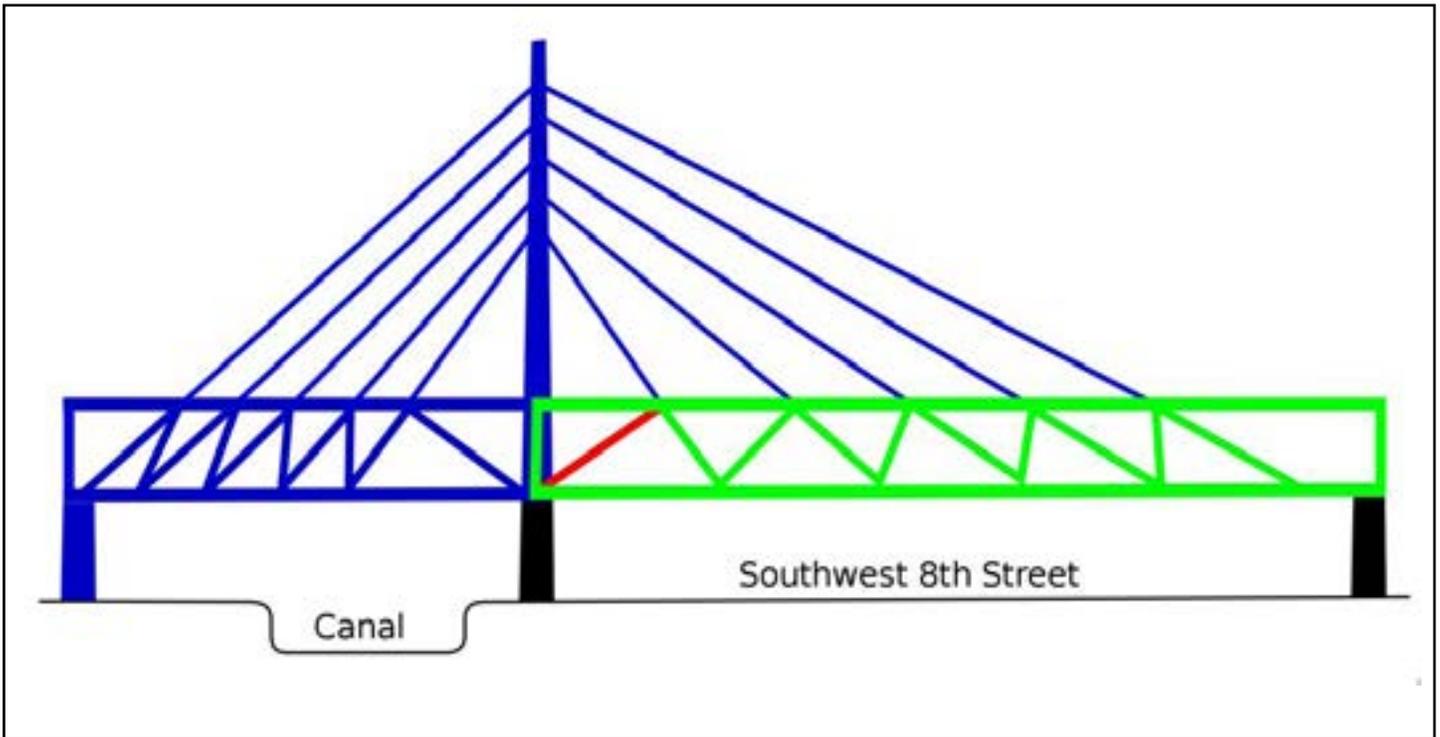
Diagram of the FIU pedestrian bridge with the critical member highlighted in red

Several independent structural engineers performed their own analyses of the bridge design and reached the same conclusion on the design. They determined the bridge’s design to be unsound, particularly at the member connecting the support column on the main span opposite from the main support column in between the two spans to the upper canopy. They deemed this member to be critical since failure in that member would cause the support column to fail, and, subsequently, cause the entire bridge to collapse. Based off the engineers’ calculations, it appears the bridge design firm made the member too thin to support the required load. The likely reason for this error fell to a miscalculation in the original design plans, since the truss contained thicker members elsewhere, but they bore less of a load than the critical member in question.

Even before the collapse, reports came in that cracks formed within the truss structure near the critical member, but the head engineer of FIGG brushed these reports off, claiming that they held no major concern. Repairs would be made to the cracks later. The day of the collapse, workers for MCM Construction, the company contracted with constructing the pedestrian bridge, began tightening internal support rods within the bridge, possibly as a method to prevent the cracking from spreading further. It is highly speculated that this tensioning increased the load within the critical member of the truss past its breaking point, causing the joint at the member and the vertical support column to fail “explosively,” in turn collapsing the entire main span of the bridge onto the highway below.
