Cracking in cycloaliphatic epoxy/aluminum composite electrical bushings

**CRACKING IN CYCLOALIPHATIC EPOXY / ALUMINUM
COMPOSITE ELECTRICAL BUSHINGS**

The problem of cracking in electrical apparatus bushings as a result of thermal stresses was investigated. The bushings were composed of cycloaliphatic epoxy insulators with embedded aluminum conductors. The problem is due to the difference in coefficients of thermal expansion of the two materials. A solution to the problem had been to coat the conductors before they were formed together with the epoxy insulators. The coating was assumed to prevent cracking by allowing movement between the two materials as their dimensions changed during thermal expansion and contraction. The contribution of the coating was to be established.

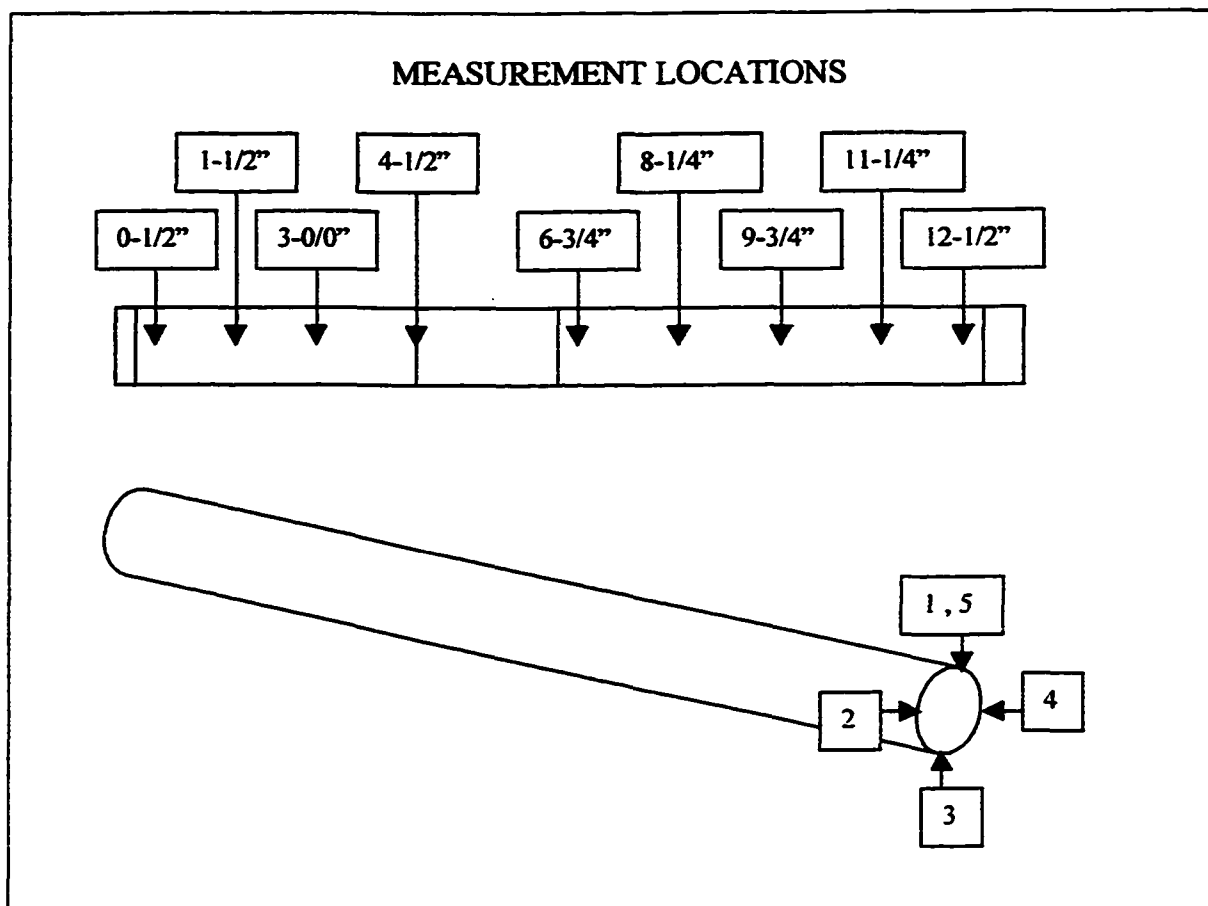
Figure 2-2. Locations for Coating Thickness Measurements

(31.80 mm) to 1.250 inches (31.75 mm). Variation in the diameter of the conductor would cause variation in the final coating thickness. The three aluminum conductors were masked in the appropriate areas with the new masking tape. All three were then coated using only the alignment sleeve. By visual inspection, the coatings were all smooth and consistent (figure 2-1). The three coated conductors were then taken to EMC for inspection. The thickness gauge utilized by EMC could not test the thickness of the coatings on the aluminum conductors. EMC arranged for the use of an Elcometer 300 coating thickness tester. The three aluminum conductors coated with the alignment sleeve (designated A, B, C) and a typical hand-coated conductor (designated E) were all tested at 36 points each (figure 2-2). The results obtained are given in tables 2-1, 2-2, 2-3, and 2-4.
